## SMALL 19<sup>TH</sup> CENTURY TABLE

## **VILNIS LĪDAKA**

## TECHNICAL CONDITION OF THE ITEM PRIOR TO RESTORATION

## **DESCRIPTION OF THE RESTORATION PROCESS**

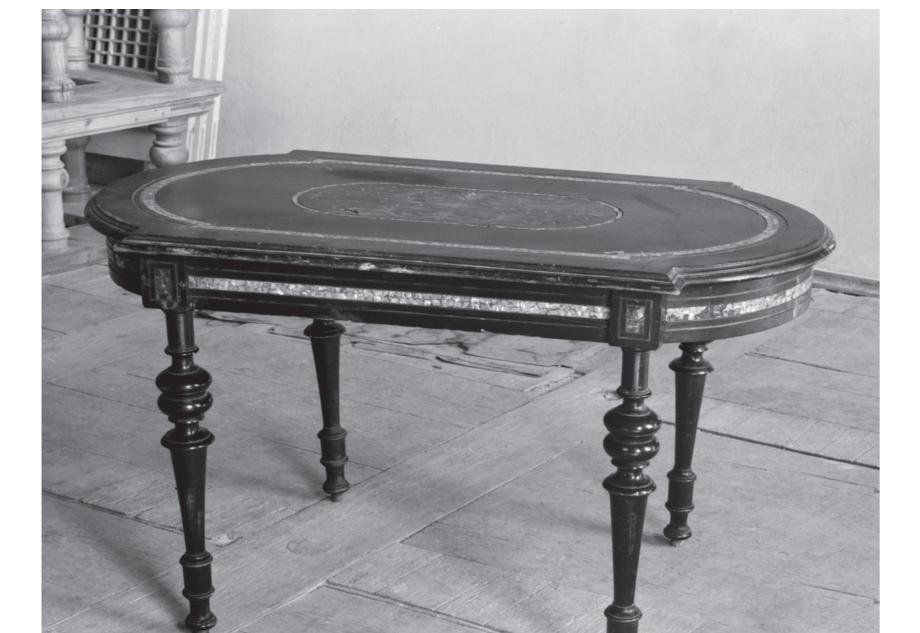
The table's construction was unstable with a lot of mechanical damage. The entire item was covered with a layer of dust and grime. The surface of the table, as well as the ornaments worked into the crown-setting using an incrustation technique, have brass applique work, mother of pearl and veneer losses. The losses of the decorative elements in the incrustation make up 50-60 %. Only a 5 cm long fragment remains of the decorative brass belt.

Fig.2 Table before restoration, photo from the year 1982

The item was disassembled. The dust and grime were removed by buffing the surfaces with steel wool. After this procedure, they were wiped down with a cotton wool tampon soaked in ethyl spirit. The brass ornament was cleaned mechanically, buffing it with fine buffing felt and polishing it. Suitable slim veneer inserts were fitted into places of veneer loss and glued with gluten glue. The mechanical damage, the small losses of veneer and any cracks were filled in with black BORMA WACHS water base acrylic putty. The filled-in spots were toned with ethyl spirit stains after the application of lacquer. Small mother of pearl plates of suitable size and form were glued into the spots where there were losses in the mother of pearl incrustation; they were mechanically thinned so as to correspond to the original, prior to their gluing. The gaps between the plates were filled with putty. The missing brass ornament in the intarsia was created anew, using a fragment which had been preserved as the analogue. The ornament was transferred to the brass plate and the required form was cut out and placed in the areas where it had been lost. The decorative brass belts were cast per the original example. After the restoration of the wooden parts, the item was assembled, using a polyvinyl acetate glue (PVA) for the gluing. The item was varnished with a toned, black shellac and polished with a shellac lacquer.

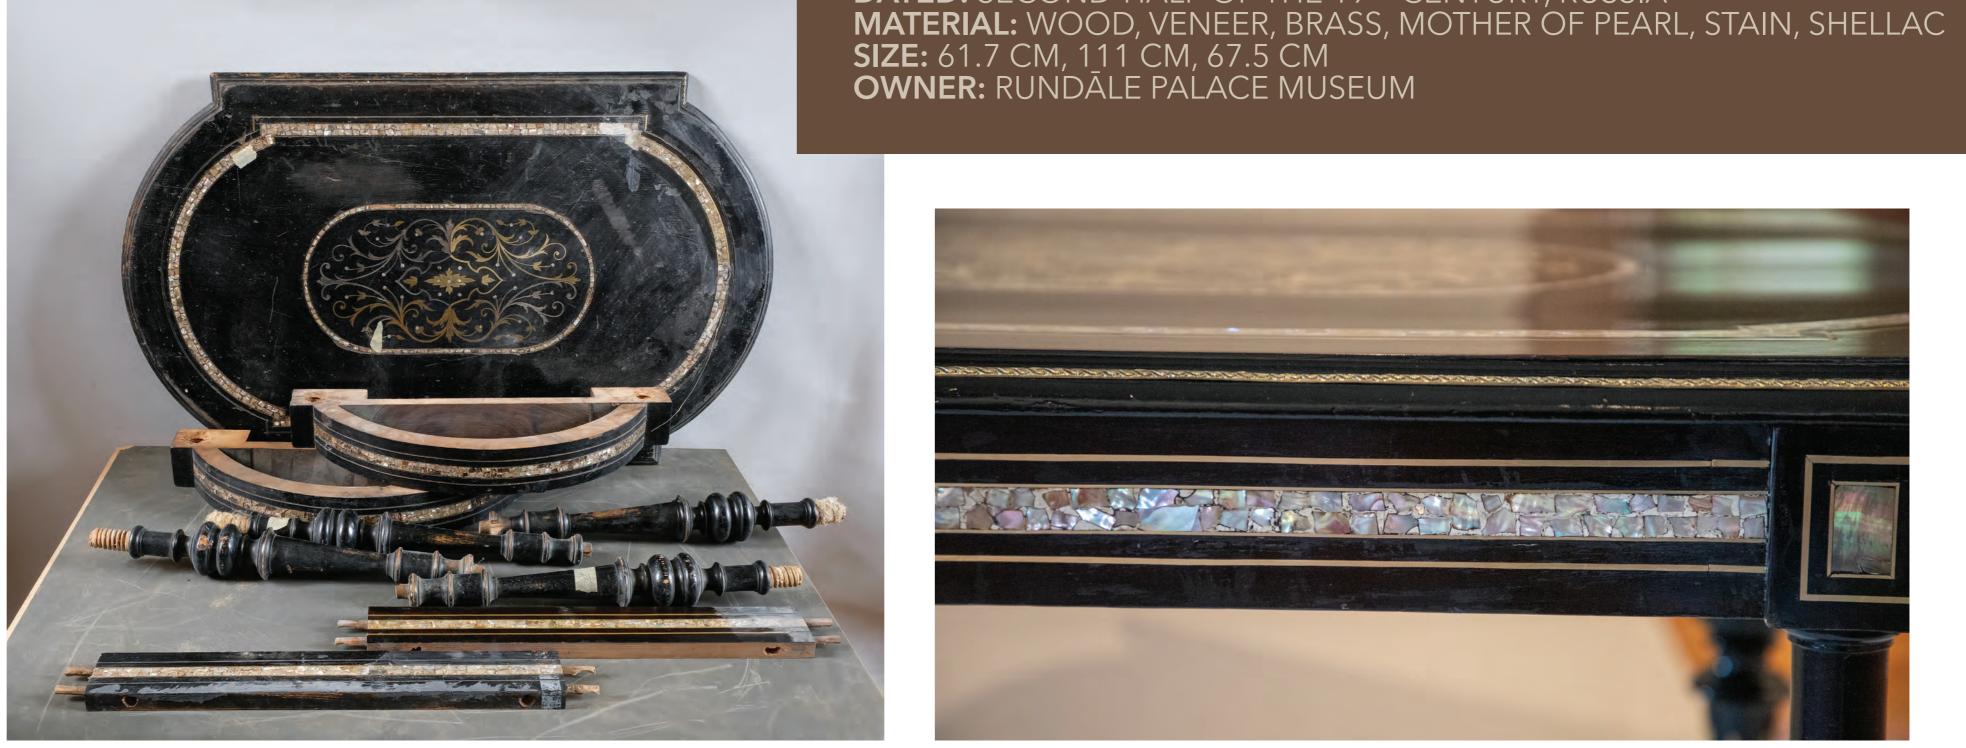
Fig.3 Process of restoration, the table is disassembled

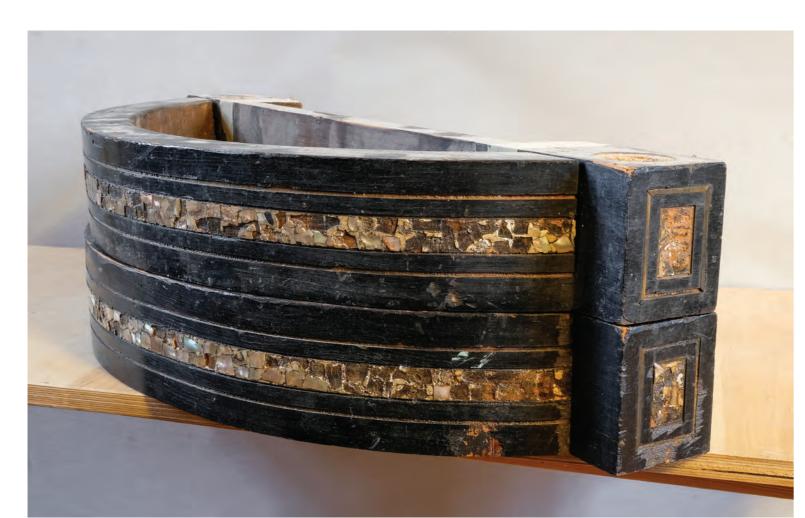
Fig.4 Details from the table before restoration

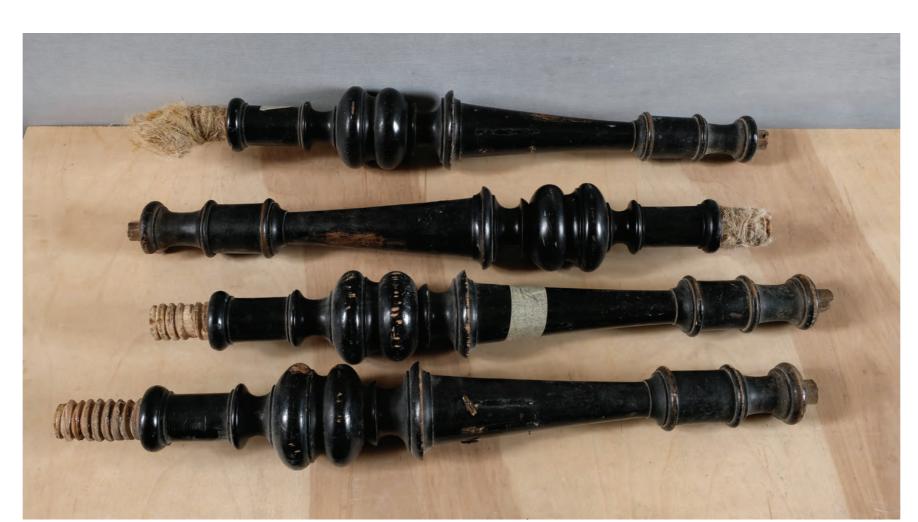
Fig.5 Table legs before restoration

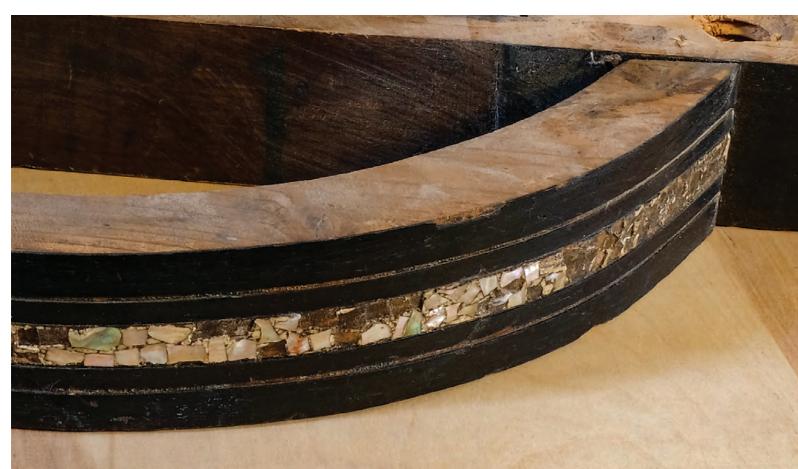
Fig.6 Fragment of the table detail before restoration

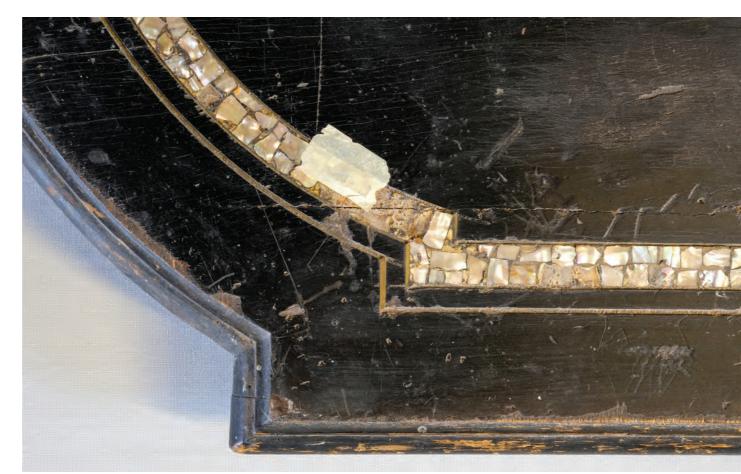
Fig.7 Fragment of the table top before restoration

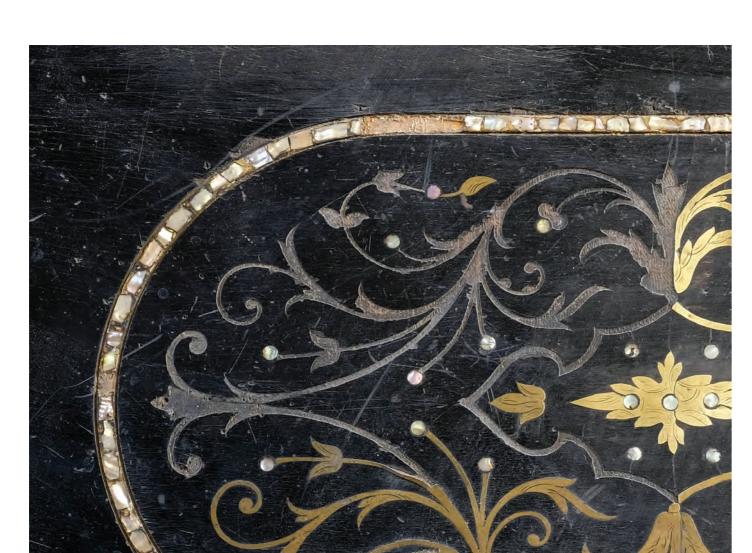
Fig.8 Fragment of the table top ornament before restoration
