THE CEMETERY  
OF THE BRETHREN IN RIGA:  
CONSERVATION OF STONE  
MATERIALS AND PROBLEMS  
OF SUSTAINED PRESERVATION

# THE CEMETERY OF THE BRETHREN IN RIGA: CONSERVATION OF STONE MATERIALS AND PROBLEMS OF SUSTAINED PRESERVATION

**Ivo Graudums**, Chief Conservation Specialist  
Riga Monument Agency  
Gaujas 19, Riga, LV-1026, Latvia  
ivo.graudums@riga.lv

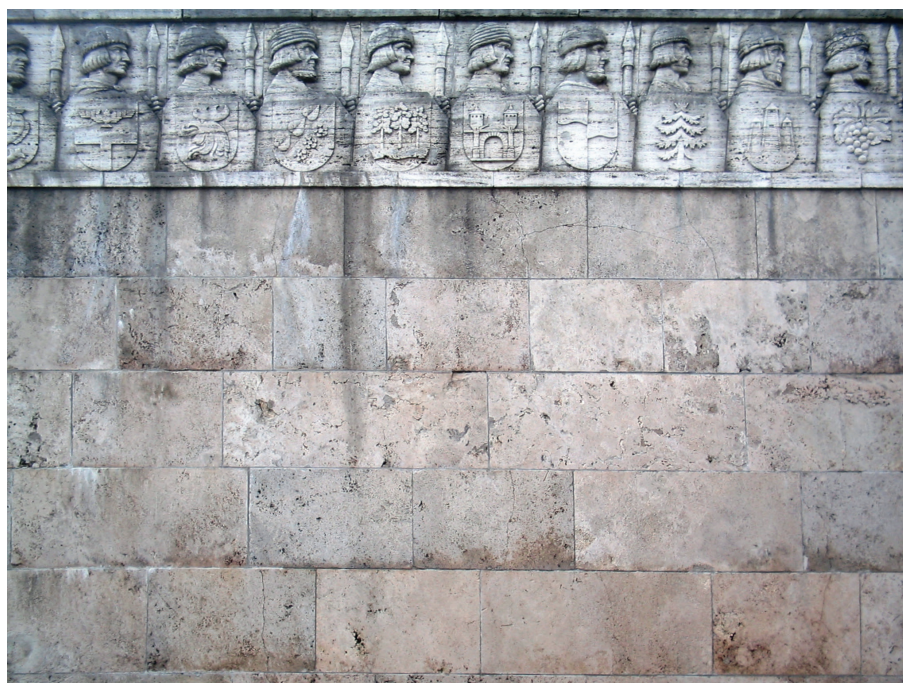
1

1. **Allaži calcareous tufa** – a type of locally sourced carbonate rock, which was used the most (Fig. 1). The main sculptural groups, wall panelling and architectonic details were all built from this material. According to written records, approximately 1900 m<sup>3</sup> of calcareous tufa were used in the construction of the Cemetery of the Brethren. Calcareous tufa is a porous carbonate rock – a kind of strongly precipitated fresh-water limestone. It consists of just one mineral – calcite (up to 99%), although often has admixtures of clay and sand – organogenetic sediments (peat and mud). The composition and amount of admixtures determine the colour of calcareous tufa. Uncontaminated calcareous tufa is either white or pale yellow, organic compounds provide light grey overtones, while iron hydroxide – yellow, fawn-coloured and occasionally, with high concentration of iron hydroxide, dark red spots. Since it is practically impossible to obtain calcareous tufa suitable for sculptural work now, in Latvian sculpture and architecture this locally sourced stone should hence be preserved as a rare and diminishing material. The Cemetery of the Brethren is one such example where large amounts of calcareous tufa that were available during the 1920s and 1930s have still been preserved to this day.

4. Roman **travertine** from Tivoli (Italy) was used for creating the sculptural details and statues (Fig. 1).

Allaži calcareous tufa and  
Roman travertine (Tivoli, Italy)

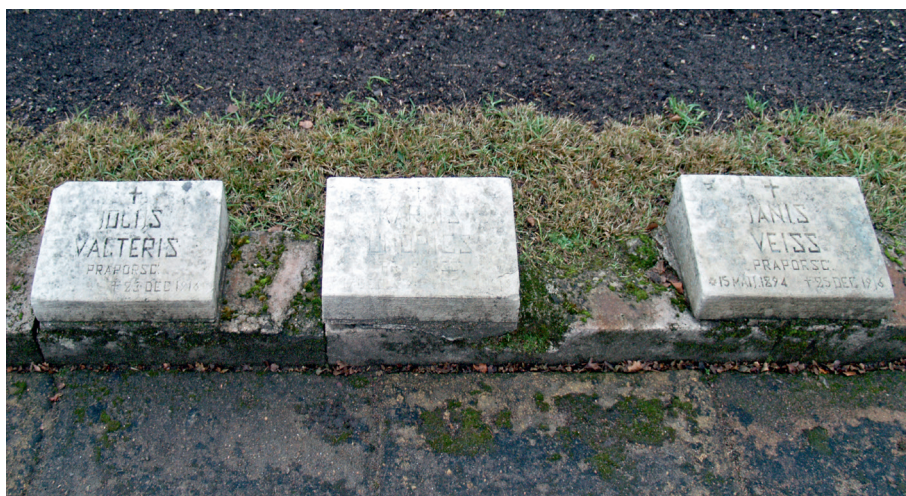
### 2

2. Locally sourced **dolomite** was used in the construction of grave plates (Fig. 2).
3. A silicon bond (cement) Oberkirchen (Germany) **sandstone** was used to make the memorial plates (Fig. 3).

Latvian dolomite

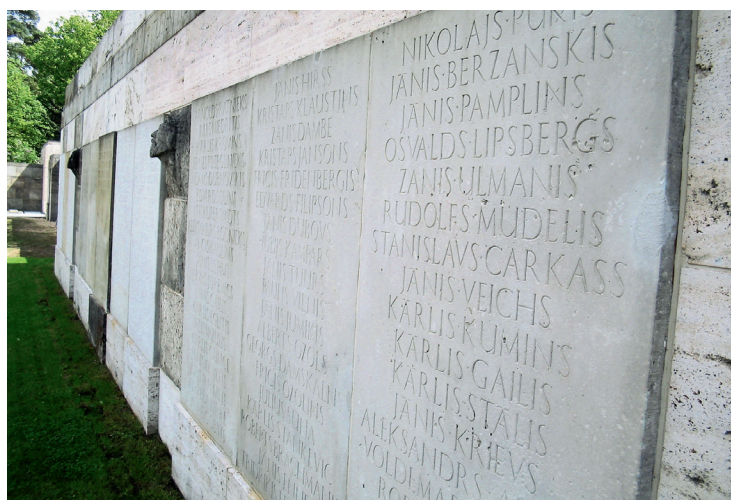
3

Sandstone  
(Obernkirchen, Germany)

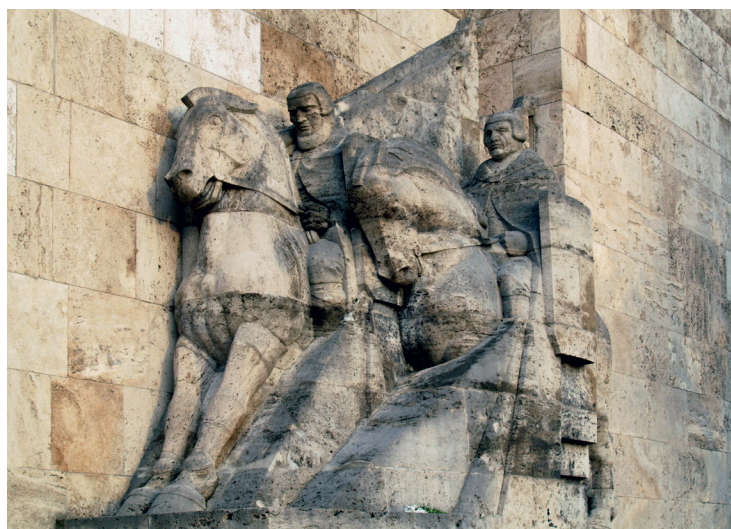
4

1. **Biological overgrowth.** Trees and shrubs surround the stone materials of the Cemetery of the Brethren creating a scenic view. Visual examination reveals discolouration, mainly darkening, of the surface of the stone together with signs of biological overgrowth – moss, lichen and microscopic mushrooms. Biological overgrowth is the main factor that changes the visual appearance of stone materials, although on this particular occasion it should only be considered as an aesthetic problem (Fig. 4).

Biological overgrowth  
on the surface of calcareous tufa

1. **Bioloģiskais apaugums.** Brāļu kapos akmens materiāli eksponēti ainaviskā vidē, koku un apstādījumu ielokā. Vizuāli konstatējamās pārmaiņas ir akmens virsmas iekrāsošanās, galvenokārt nomelnēšana, un bioloģiskā apauguma – sūnu, ķērpju, mikroskopisko sēņu – attīstība. Bioloģiskais apaugums ir galvenais faktors akmens materiālu vizuālā izskata izmaiņām, taču konkrētajā objektā uzskatāma vairāk kā estētiska rakstura problēma (4. att.).

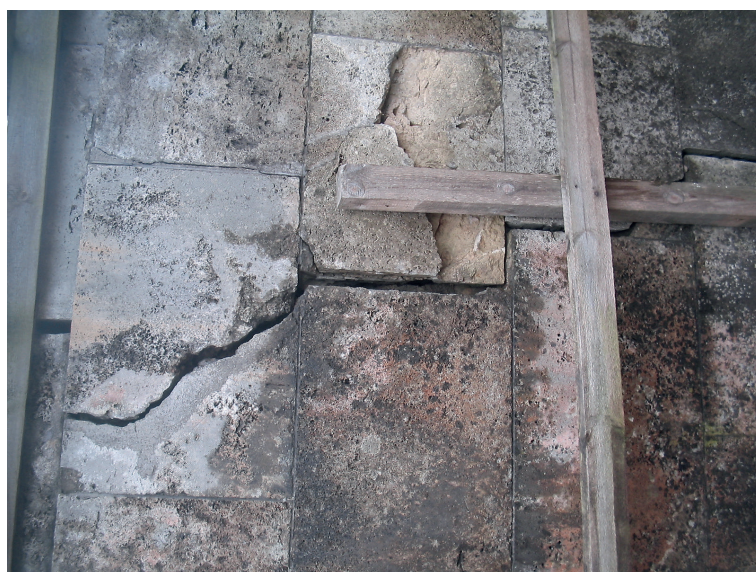
6

4. **Construction deformation.** The deformation of masonry constructions constitutes a serious problem for the preservation of stone materials on this site (Fig. 6). Insufficient preparation of the foundation and load-bearing walls are just some of the mistakes conceded during the original construction works. However, further large-scale damage of calcareous tufa that can be presently observed stems from neglectful and improper maintenance while the site has been in use.

Anchor fasteners made from rusting steel have caused additional damage to the stone plates. Cracks have appeared and the plates have fragmented as a result of corrosion tension, and the ensuing fractures in stone material reveal anchor fasteners that over time have completely rusted.

The result of construction deformation

4. **Konstruktīvas deformācijas.** Nopietna problēma ansambļa akmens materiālu saglabāšanā ir ansambļa mūru un sienu konstrukciju deformācijas (6. att.)  
Deformāciju cēlonis ir jau ansambļa celtniecības laikā pieļautās kļūdas, nepietiekami sagatavojot pamatus un mūrējot kodolmūri, savukārt šodien konstatējamo apjomīgo šūnakmens bojājumu cēlonis ir ansambļa ekspluatācijas laikā nepilnīgi veikti aprūpes pasākumi.

Akmens bojājuma apjomus vēl palielina celtniecības laikā akmens plākšņu stiprināšanai izmantotie rūšējoša metāla enkuri. Rūsas sprieguma rezultātā apšuvuma plāksnes ir stipri saplaisājušas, sadalījušās vairākos fragmentos un ir konstatējami akmens materiāla izlūzumi, kur atsedzas sarūsējuši metāla enkuri.

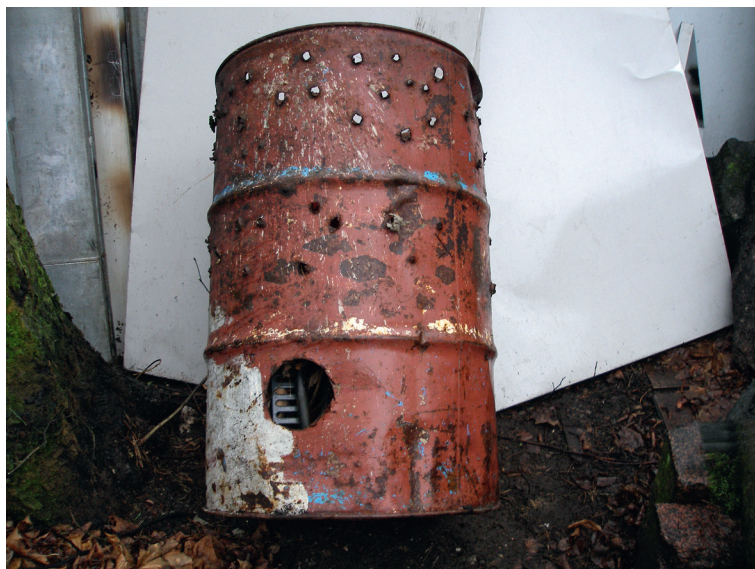
4. **The attitude of professionals and work executors towards the site.** On occasions the executors of conservation works are more interested in the profits and will do everything to avoid incurring losses. This attitude manifests itself through the use of cheap and poor quality materials, for example, the built-in rainwater collection system in one of the depositories (Fig. 9). Therefore, it is highly questionable whether such executors are worthy of the title 'professionals.' The situation is aggravated also by the purchase system used by the state and local authorities, where the cheapest price often constitutes the most favourable option, as opposed to a better and more professional execution.

3. **Vienotas restaurācijas un aprūpes metodikas trūkums**, kā rezultātā ansamblis tiek vizuāli sadrumstalots. Piemēram, dažāda šuvju pildmateriālu klāsts, kas izmantots ansambļa restaurācijā. Cēlonis – spēcīgs gatavo rūpniecisko sastāvu ražotāju mārketinga, kas arī bieži tiek realizēts caur amatpersonu lobiju un restaurācijas nozarē ir globāla problēma. Latvija šajā ziņā nav izņēmums.
4. **Profesionāļu un izpildītāju attieksme pret objektu**. Ne tikai amatpersonas grēko, bet nereti arī izpildītāja attieksme pret restaurācijas procesu aprobežojas tikai ar plānoto peļņu un tiek darīts viss, lai plānotās peļņas daudzums nesārukstu. Lielākoties tas izpaužas nekvalitatīvu un lētu materiālu lietošanā. Konkrētajā gadījumā redzama iebūvētā lietus ūdens savākšanas sistēma

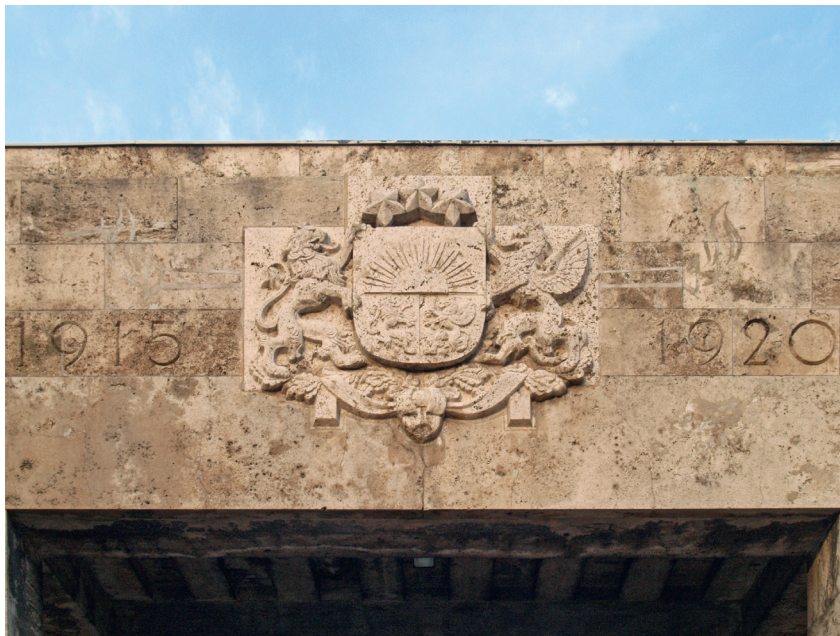
## 10

Analogue replacement  
material for calcareous tufa  
(Langesalzer travertine)

Hence the conservation of calcareous tufa is a complicated and expensive process. In the absence of a consistent conservation methodology, this task has often been oversimplified resulting in an unjustifiable loss of original material and alterations in the site's visual appearance. For example, according to geological research, both travertine from Germany and locally sourced dolomite from the Birži quarry have been recommended as a replacement material (Fig. 10). Travertine has been used in parts that are visible and important elements of the site and dolomite – everywhere else. Although these two types of stone have been used in the conservation of calcareous tufa for over ten years, it is important to have a considered approach so as not to overshadow the original material. It is also essential to ensure that the surface texture of the new stone materials, like the German travertine, matches the original texture of calcareous tufa.
